Applying for Hardboard Siding Settlements

A Guide Based upon Experience

**Homeowners Against Deficient Dwellings
December 2003**

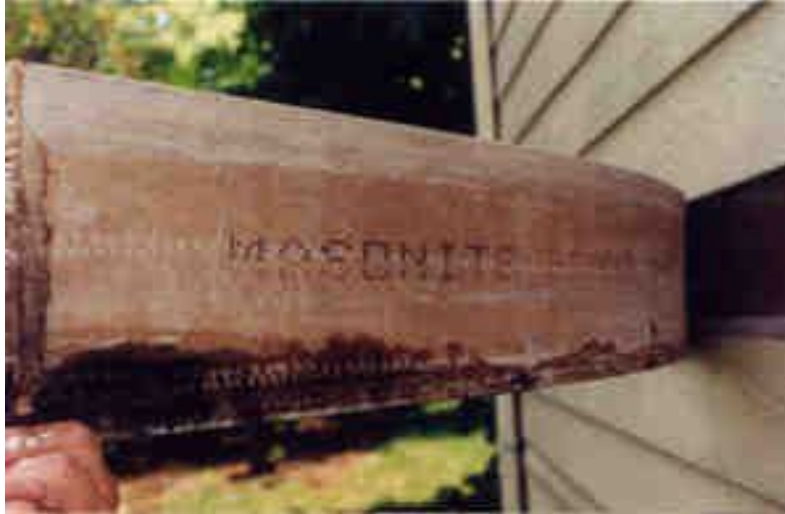
- Find an exposed area of the back of the siding. Look in an unfinished garage or in the attic. Tear back the insulation or tarpaper from the back of the siding to expose the backside of the board. Look for any identification marks. (Example markings are define in the next section)
- Remove or pull back a board of siding. Look for markings.
- If you can't find markings, notice the texture of the back of the siding. This could give clues to the manufacturer. Is it smooth or with a waffle iron pattern? Is it wood chips? Large or small? What is the color of the back?
- Ask your builder what they used in construction of the home.
- Check your closing papers for warranty information.
- Ask your neighbors if they have ever removed siding or applied for any settlements.

And example of how to check for markings.

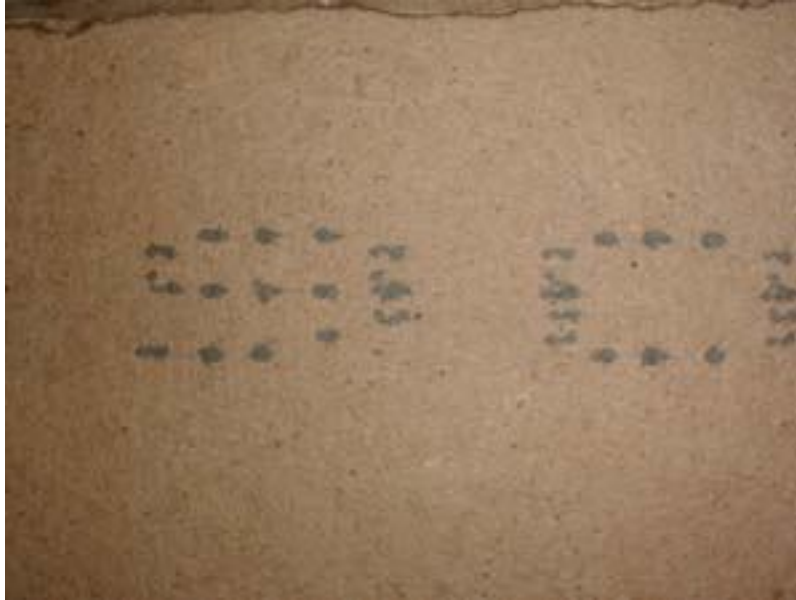
An example of smooth Masonite backing with dot letters.

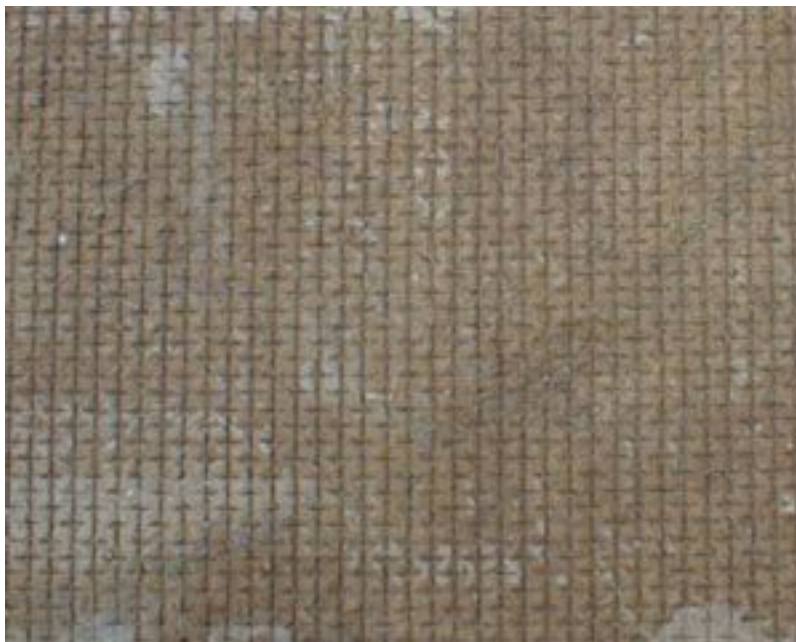
An example of the waffle Iron pattern for Masonite siding

Some Masonite has a very distinctive pattern on the backside resembling a waffle iron pattern. Others have a smoother dark pattern. Many boards will be marked with MASONITE. MASONITE BRAND, SUPERSIDE, X-90, or a big M (masonite logo) Sometimes the letters will be solid or formed by dots. And other times, there just isn't any markings to help.

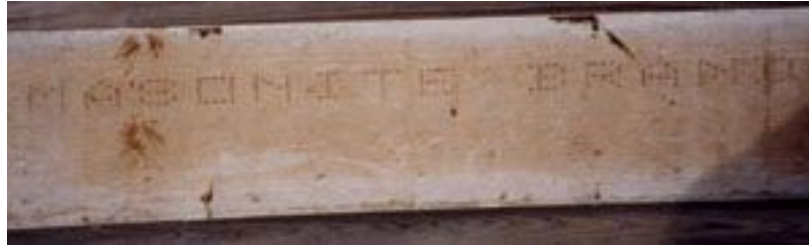
An example of one of many stamps made with dots.

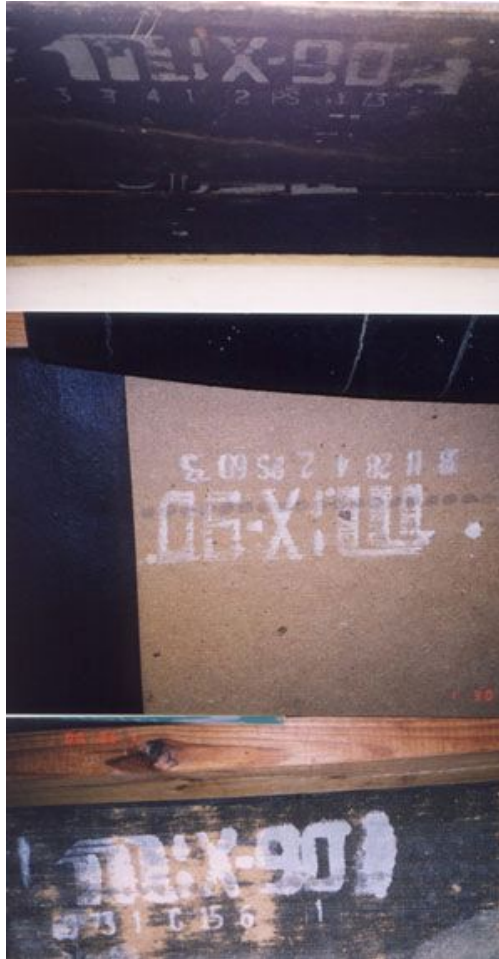
Various Examples of X-90 Masonite stamps.

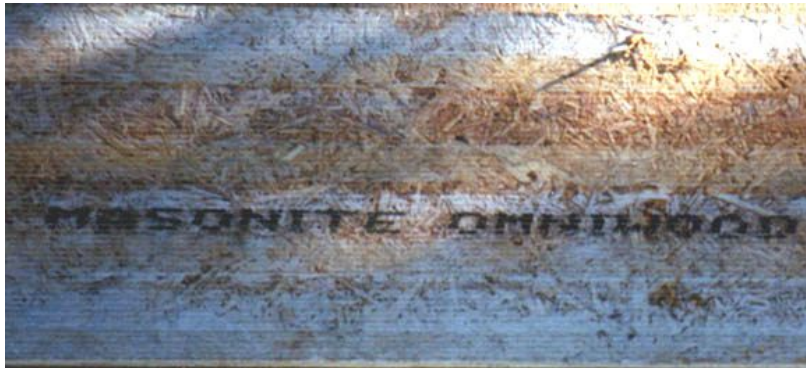
Omniboard is composed of fine toothpick sized wood chips glued together. Sometimes the words MASONITE OMNIWOOD can be found. Compare to the larger wood chips of LP siding.

Omniwood Masonite Siding

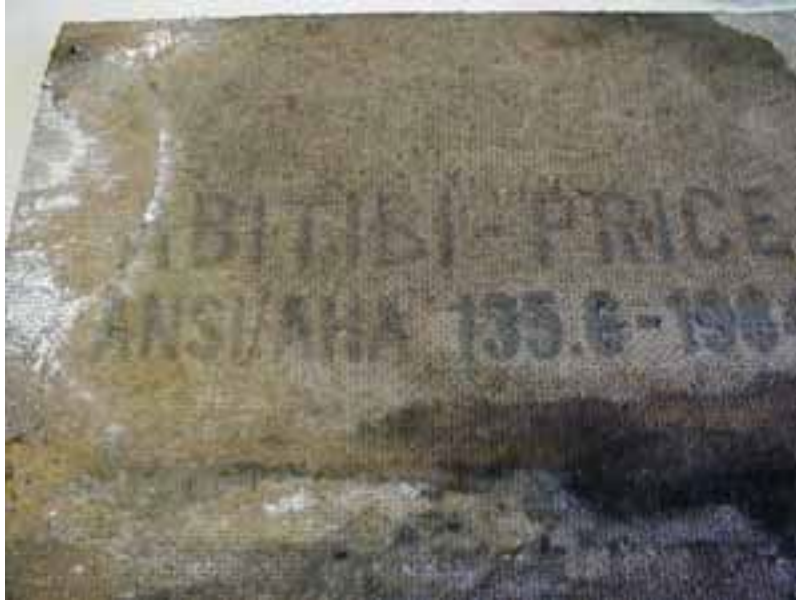
Abitibi- Price siding Stamp

ABTco also has a type of waffle iron pattern, which is sometimes confused with Masonite. It also could have a series of numbers used to identify when the siding was manufactured. More information and pictures about this can be found at their website at www.abtcoclaims.com. Sometimes the word ABITIBI-PRICE, or ABTCO will be printed on the boards.

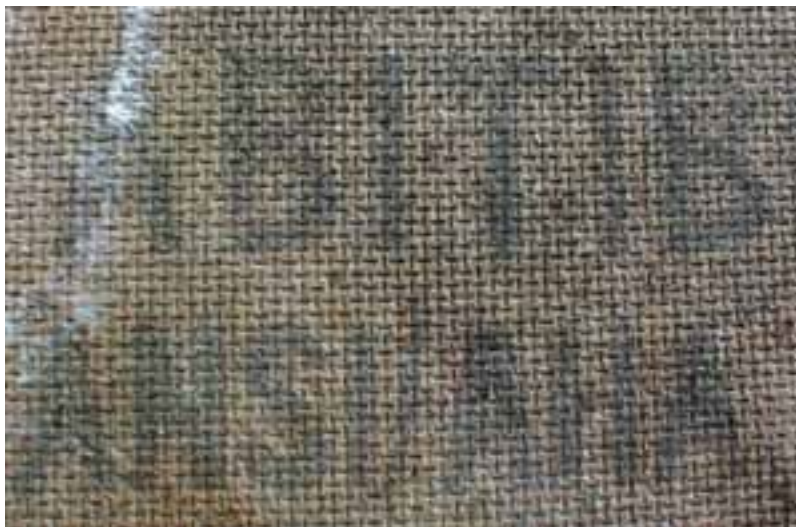
Abitibi/Abtco backside rough waffle iron pattern

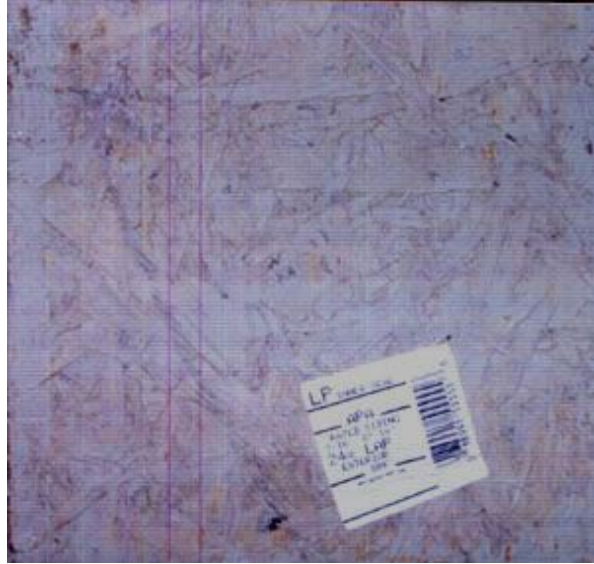
This siding is composed of large wood chips. It tends to flake when wet. Compare to the smaller chips in Masonite Omniwood.

LP Siding backside pattern with large wood chips.

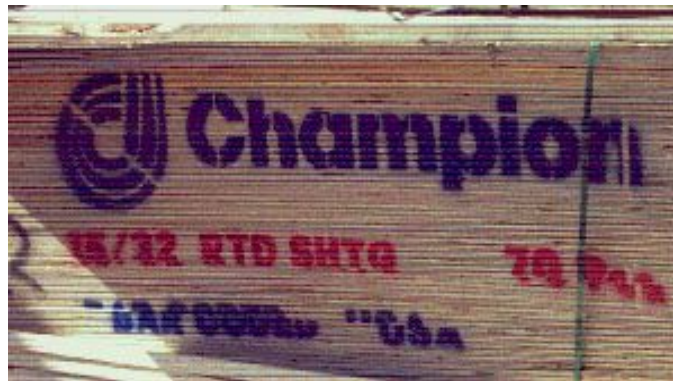
Usually a smooth background with a circle of Cs.

Champion siding stamps.

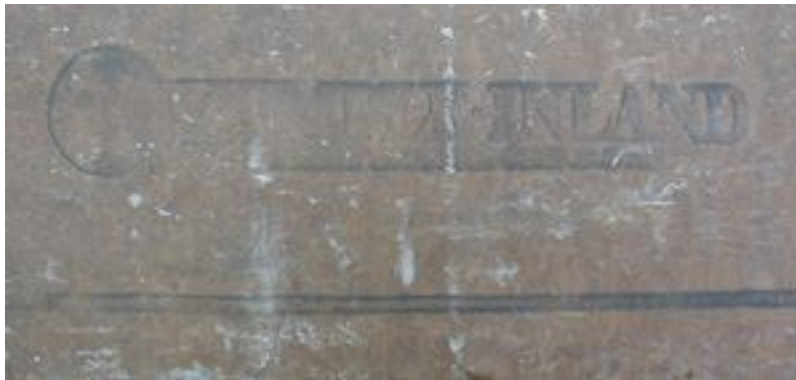
This siding is usually smooth on the back and may have AHA CONFORMA, TEMPLE EASTEX, TEMPLE INDUSTRIES, TEMPLE INLAND, or a series of Ts in the shape of a wagon wheel.

Temple Inland Siding

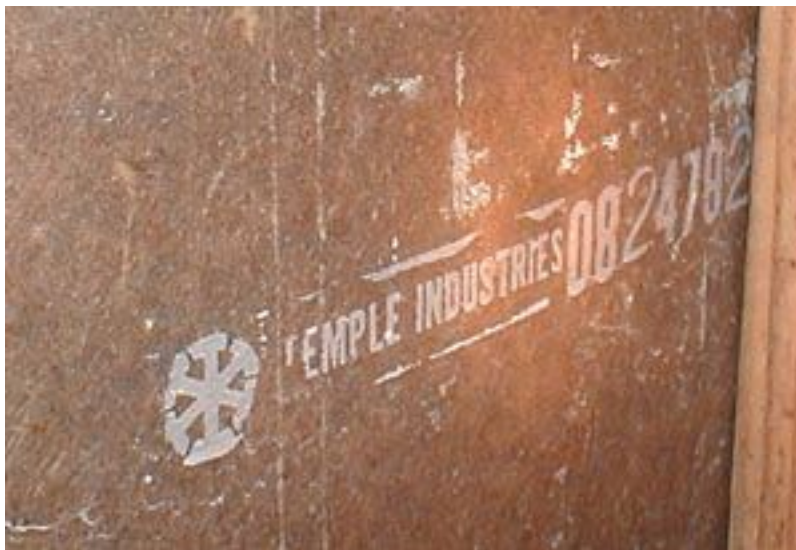
Temple Industries and the Circle of Ts

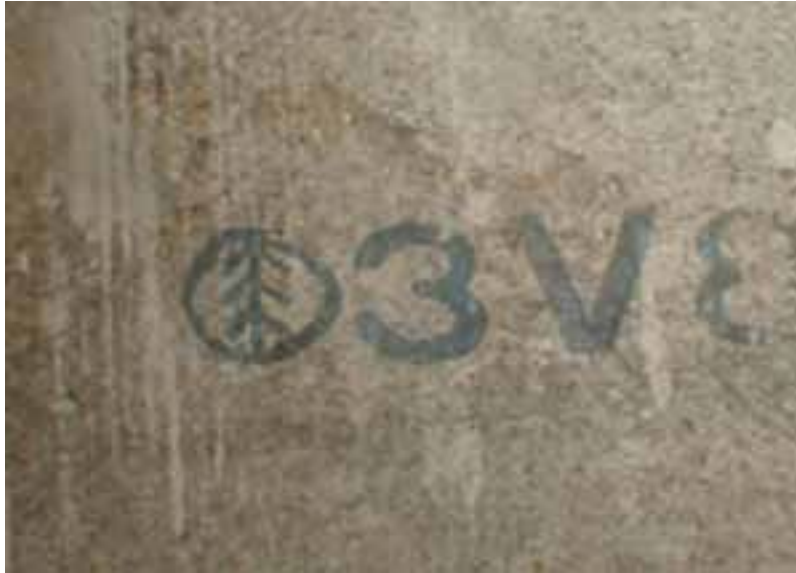
Could have a tree inside of a circle. It usually is very smooth on the back.

Boise Cascade Tree in a circle

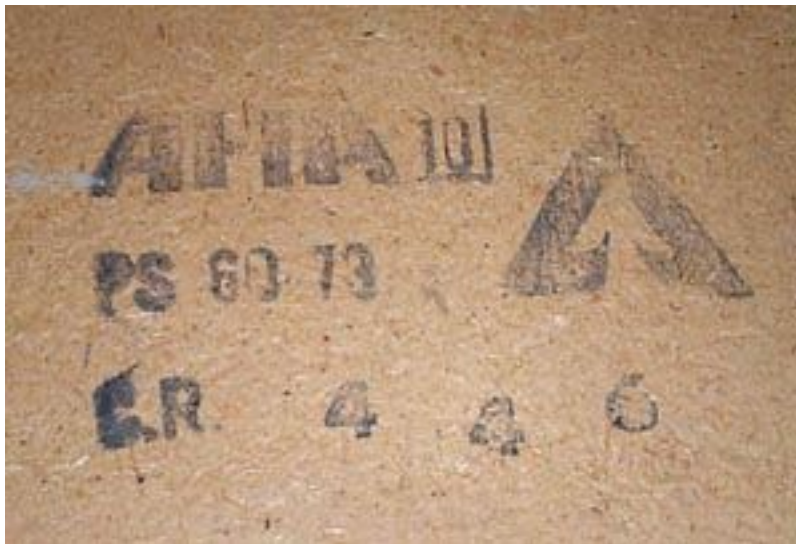
Look for AHA 10 stamp, the tree in the triangle, or the word Weyerhaeuser.

AHA 10 Weyerhaeuser Tree in a triangle

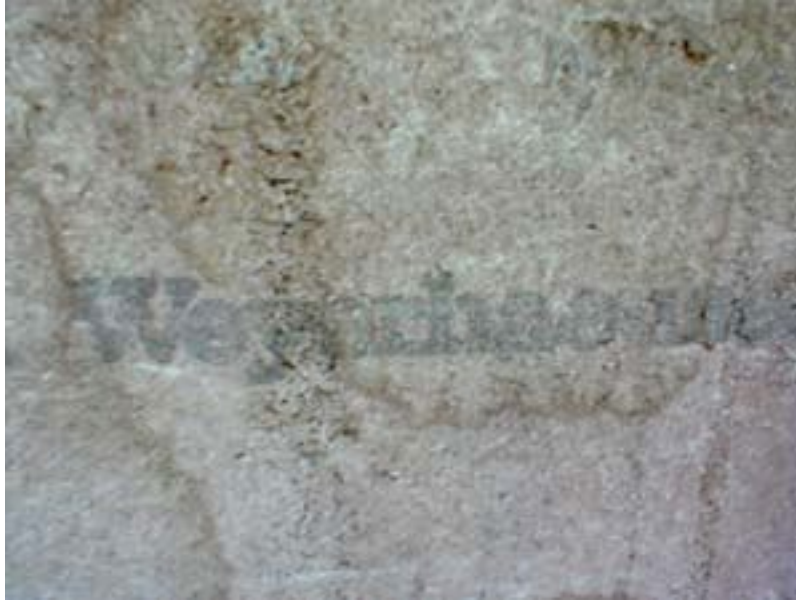
Weyerhaeuser Stamp

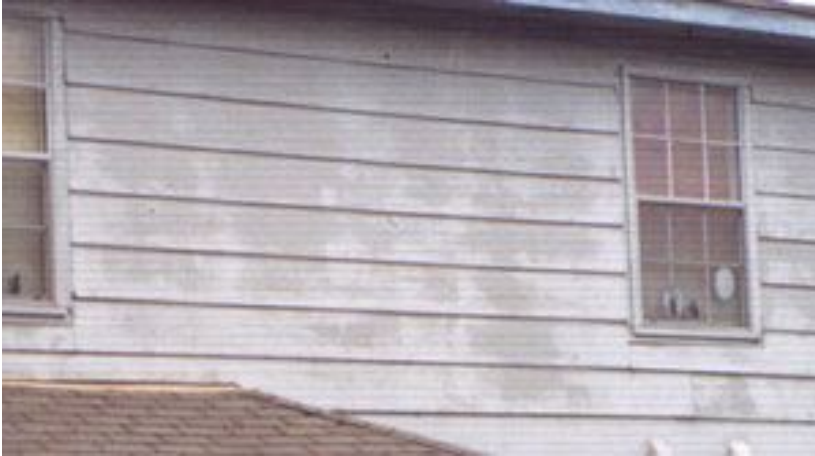
Wax Bleed

Wax bleed looks like the board is wet. Usually the discolorization will seep through the paint in about 2 years.

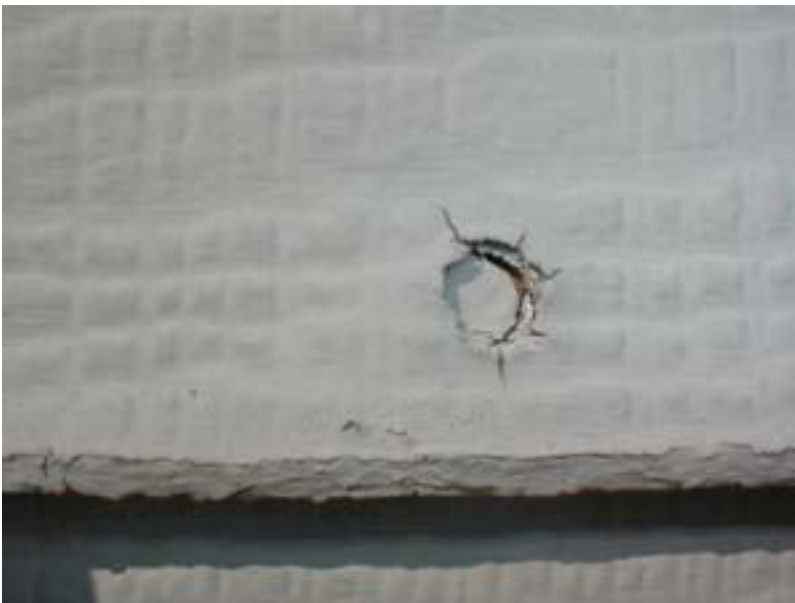
Swelling Around the Nail Holes

The board begins to swell around the nail holes sometimes giving it a look of over driven nails.

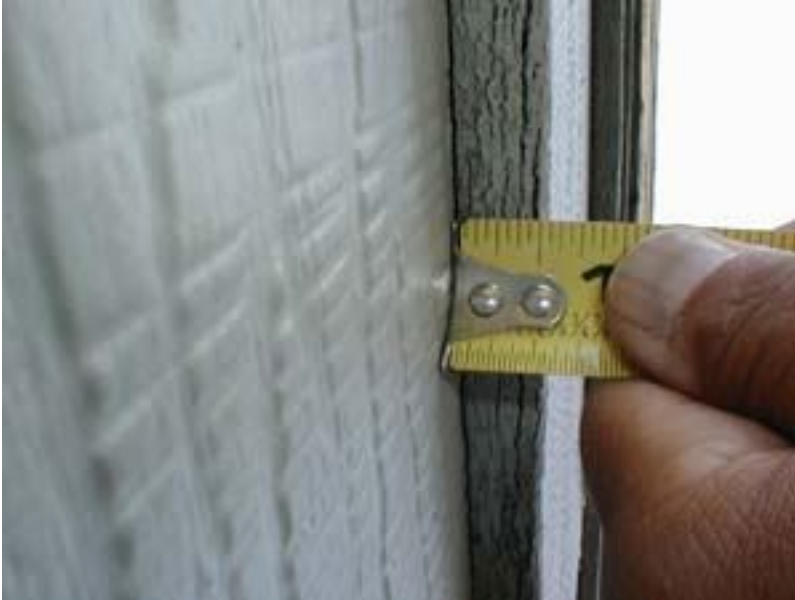
Swelling of the board over a certain tolerance. Usually this is detailed in the settlement. For Masonite as an example, $1/16^{\text{th}}$ of an inch for a board measuring $7/16^{\text{th}}$ of an inch in thickness is the tolerance level. Most of the swelling will occur at the drip edges, that is the bottom edge of the board where water will drip off.

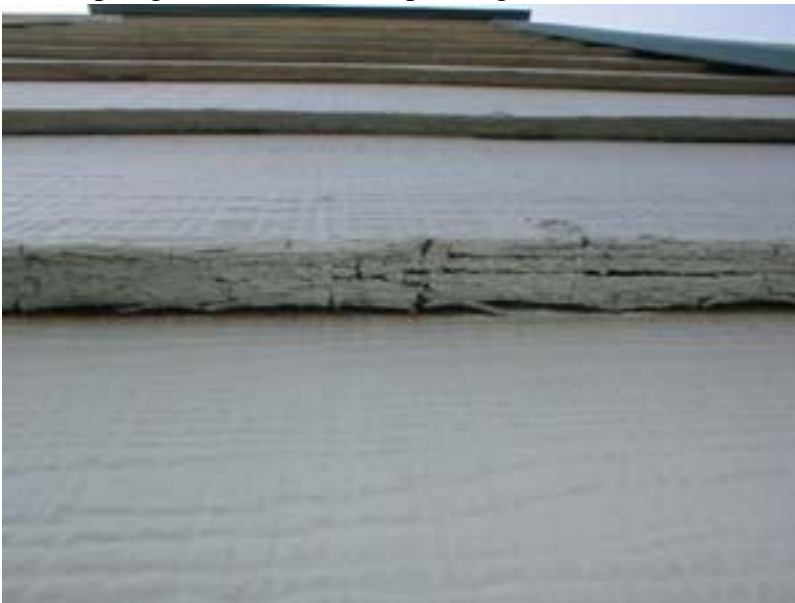
Edge Checking

The drip edge of the board is separating.

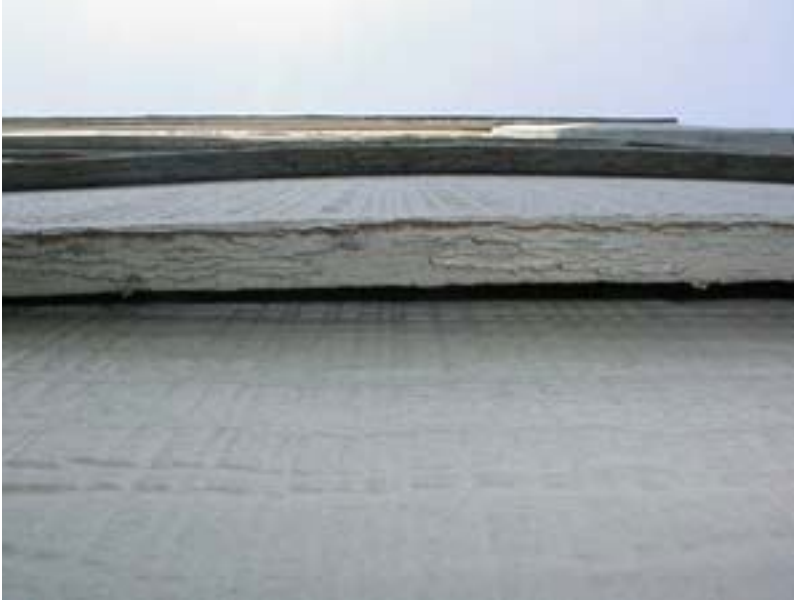
Fissures

Small cracks develop on the drip edge and start running the length of the board. Water then hangs on the edge and gets absorbed through the fissures. (Or so goes the theory)

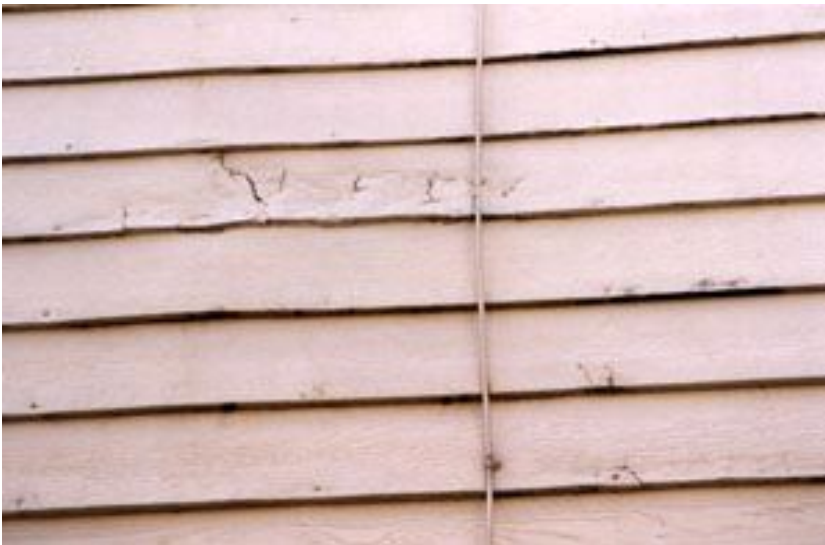
Fungal Degradation

The board is soft to the touch.
